Dalkeith *Heritage Regeneration*

Repair and Maintenance of Historic Buildings in Dalkeith Home Owners Guide

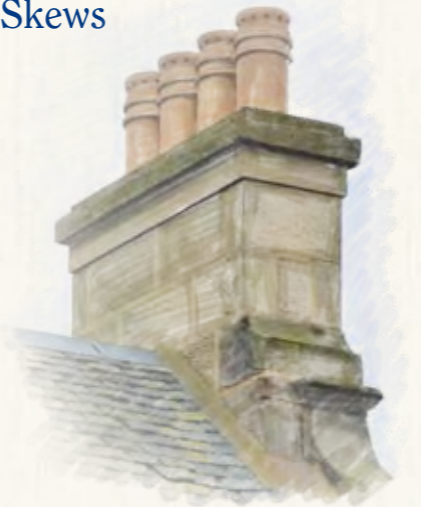
Chimney cans (pots) are generally made of clay and set into

a stone cope on top of the chimney stalk and haunched with cement. Skews are the stone cappings to the gable walls against which the slate roof abuts. The joint is formed with a concealed lead flashing, or, more commonly a cement fillet as on a chimney. Skew stones are bedded and pointed in lime mortar on the sloping top of a gable wall and maybe supported at the foot by a shaped stone called a skew putt.

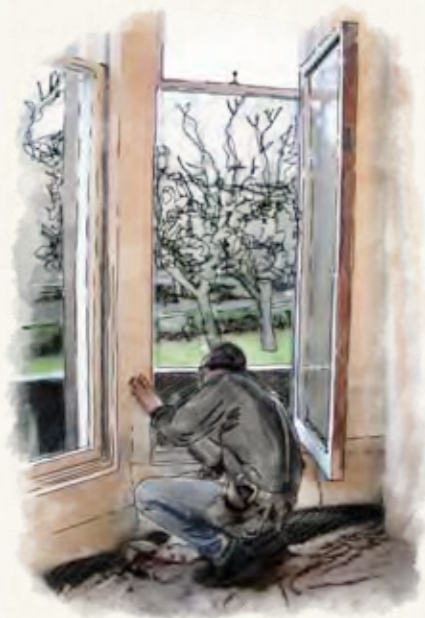
The majority of original windows in the town were either casements or sash. These windows provide the maximum amount of daylight through an opening; give controllable ventilation, effective security and do not project from the face of the wall like some modern substitutes. If traditional windows have deteriorated the first recommended course of action is repair. This can be carried out by an experienced joiner. Repairs can be carried out more cheaply than

replacement with another style or material and will maintain the original character and fabric of the house. If the building is listed then formal consent would be required for any change to the appearance of the windows.

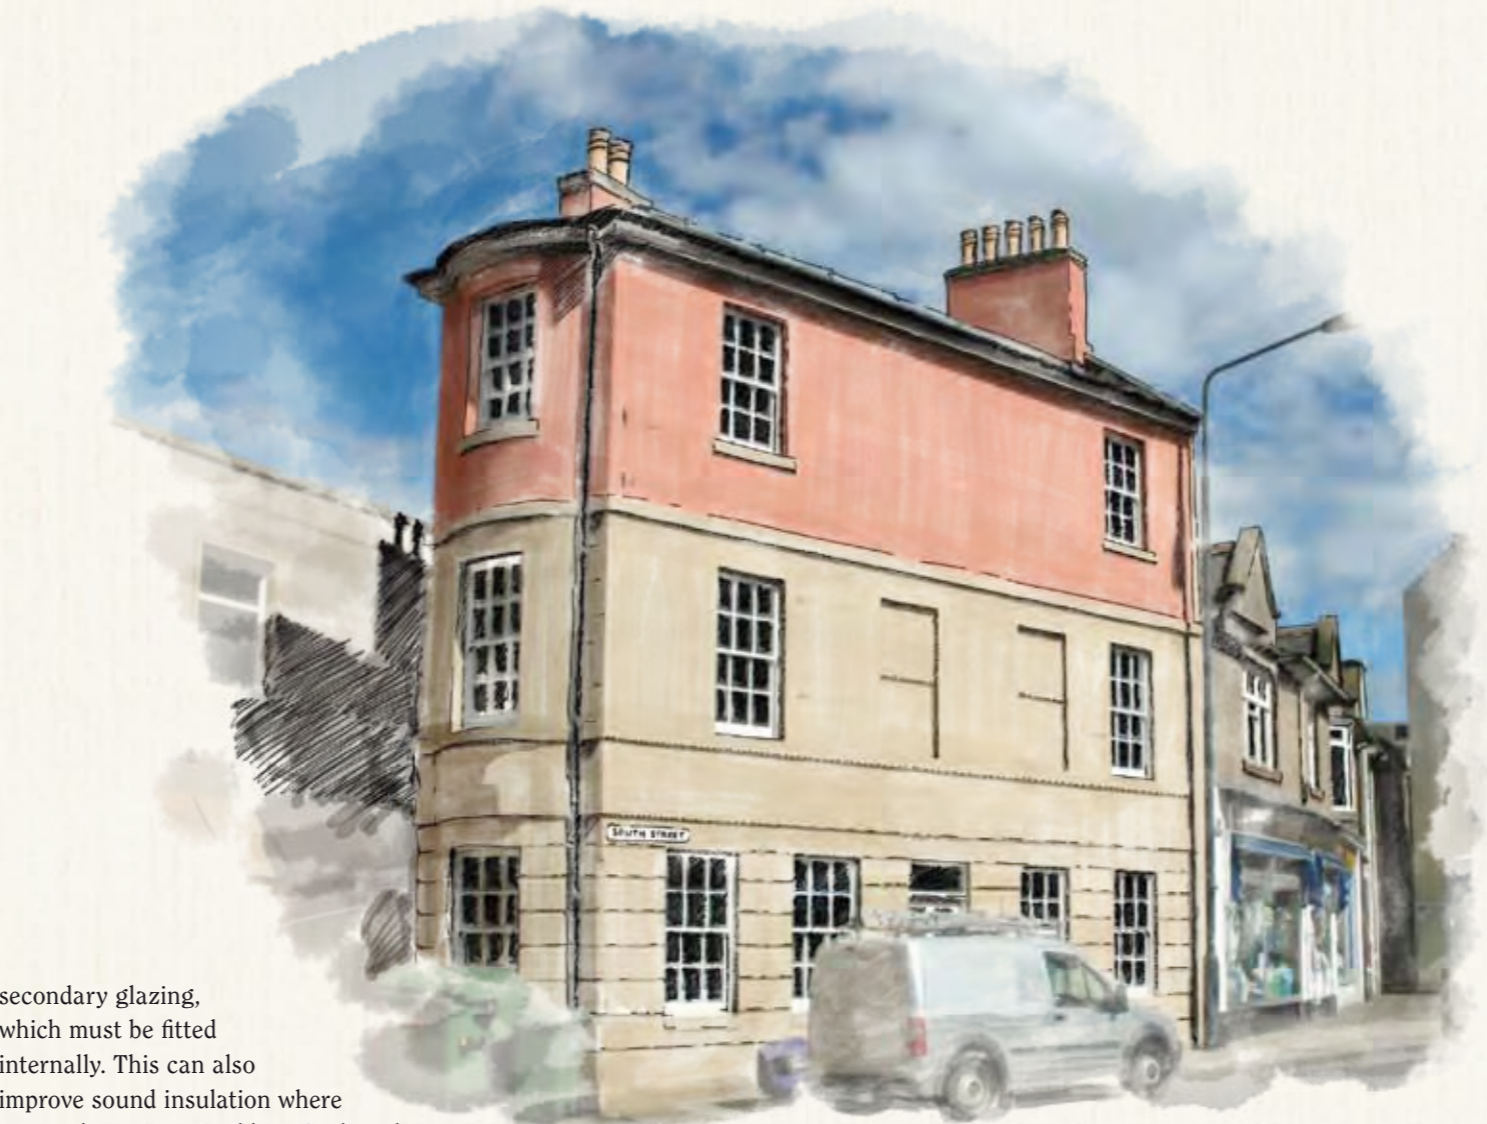
Window maintenance should pay attention to the condition of the paintwork and should include regular inspection of the timber cills. Wear in sash cords and shrinkage and wear in the frame can cause draughts. All can be repaired by a joiner with materials to match. The thermal insulation value of sash windows can be improved with draught stripping or

secondary glazing, which must be fitted internally. This can also improve sound insulation where external noise is a problem. Sash and case windows are hung on Simplex hinges to allow inward opening for safe cleaning – useful on upper floors.
